# Oakland Plantation Big House Historic Structure Report

CANE RIVER CREOLE NATIONAL HISTORICAL PARK  
OAKLAND PLANTATION

~ BIG HOUSE ~

HISTORIC  
STRUCTURE  
REPORT

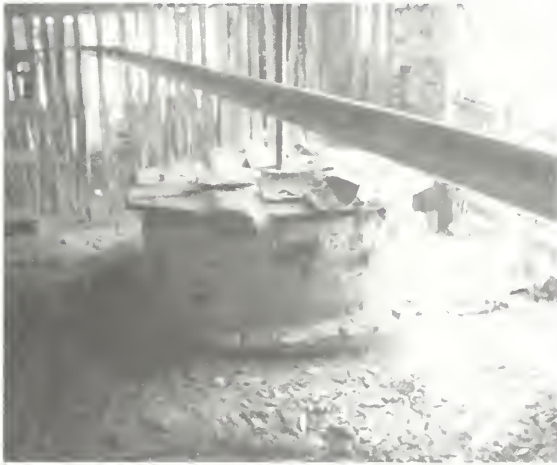
The most prominent site features that were historically associated with the Big House were the cisterns. Two of these are still intact although no longer in use. Both are underground cisterns, one beneath the west end of the gallery on the south side of the kitchen wing and another beneath the pump on the rear gallery of the house itself. A third underground cistern was located under what is now the southwest corner of Room 214B, but it collapsed and was filled in by NPS personnel in 1996. Two above-ground water tanks were features of the site through most of the twentieth century. Both consisted of cylindrical,

**Figure 29** View of cistern beneath rear gallery. (NPS-SERO-CRS, 2001)

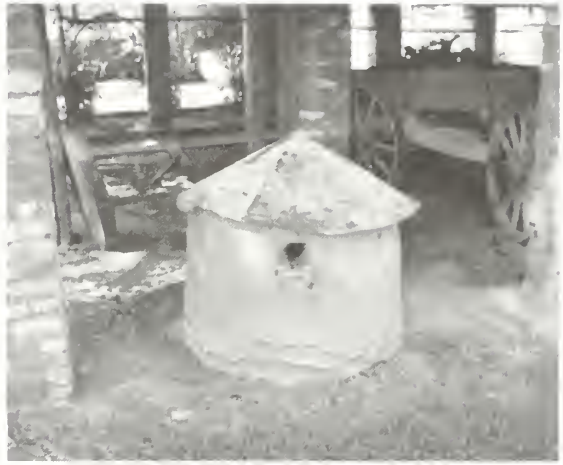
**Figure 30** View of cistern beneath kitchen gallery. (NPS-SERO-CRS, 2001)

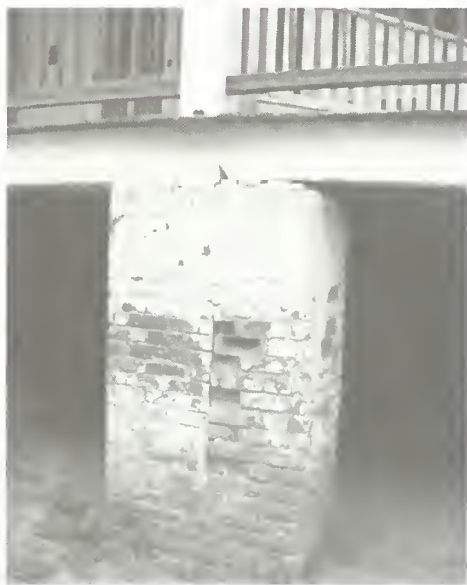
**Figure 31** Brick piers on north end of east gallery. Pier at left is from the original house, c. 1821; pier at right is from the first expansion of the house, c. 1825. (NPS-SERO-CRS, 2001)

- Reconstruct missing pier under Room 214A, tilting pier under Room 212, pier at northeast corner of house, and piers under south gallery of kitchen and elsewhere if necessary.
- Repoint remainder of masonry, avoiding any treatment of north wall of Room 106.
- Repaint paling enclosure around foundation and exposed brick piers; unpainted brickwork on the gallery stairs and on the south, west, and north sides of the foundation should not be painted.

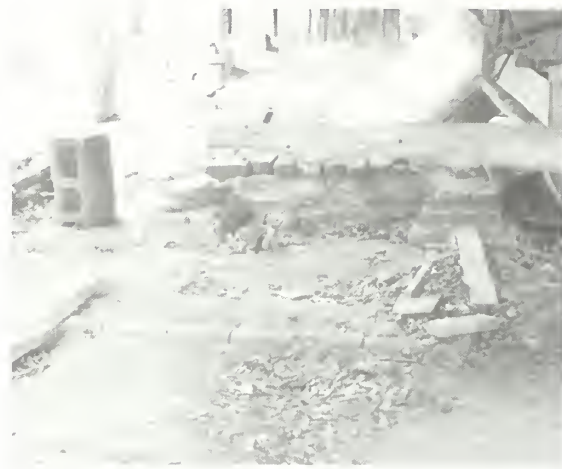
**Figure 32** Demolished foundation for fireplaces under kitchen wing. (NPS-SERO-CRS, 2001)

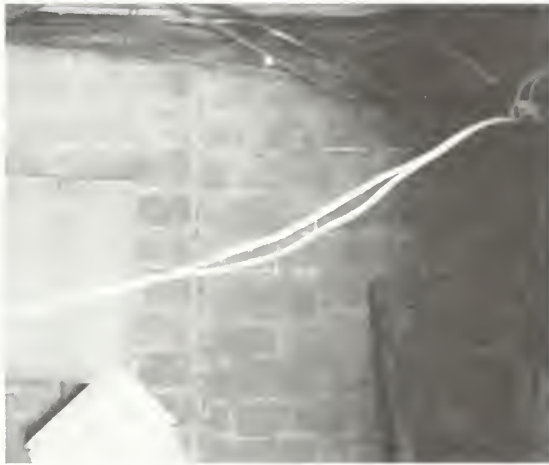
**Figure 33** Detail of north wall of gas room (106), showing two earliest generations of brick work, both with mortar joints pencilled in white over red. (NPS-SERO-CRS, 2001)

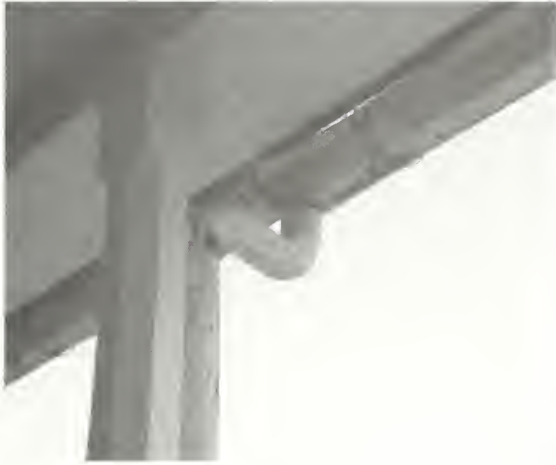
**Figure 36** Typical semi-octagonal gutter and round downspouts, which date to early twentieth century. (NPS-SERO-CRS, 2001)

- Monitor effectiveness of current roof repairs and how frequently the coating requires renewal.
- If suitable replacements can be found, replace missing ridge shingles.
- Repair metal roofing and flashing; properly prepare both and repaint with appropriate silver-colored paint.
- Reinstate horizontal downspout at west end of kitchen wing.
- Repair existing gutters and downspouts, replacing only those portions that have rusted beyond repair.
- Keep gutters and downspouts painted, including the interior of the gutter trough. Exterior should be painted white; interior of gutter trough should be painted with appropriate rust-inhibitive coating.
- Insure rapid drainage of downspout runoff away from the house.

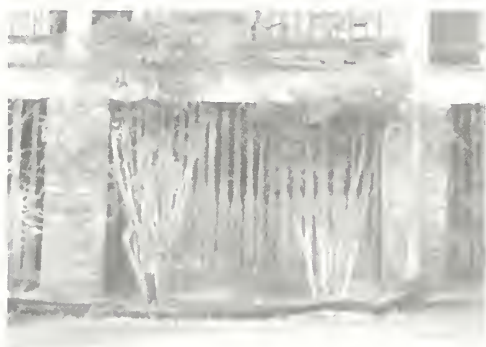
*Foundation Enclosures:* Before the Civil War, there was apparently no enclosure of the foundation piers around the perimeter of the house. The brick walls of the basement rooms remained clearly visible and were painted red with "pencilled" mortar joints. Fragments of that treatment can still be found in Room 106 (see description below) with red paint still visible on the brick at several other locations. The

**Figure 39** Views of earliest type of foundation enclosures, (c. 1870). (NPS-SERO-CRS, 2001)

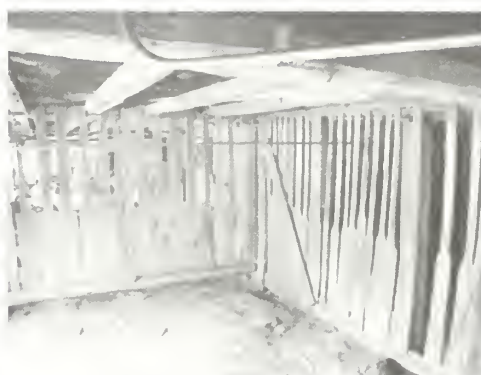
**Figure 40** View of a somewhat of foundation enclosure. (NPS-SERO-CRS, 2001)

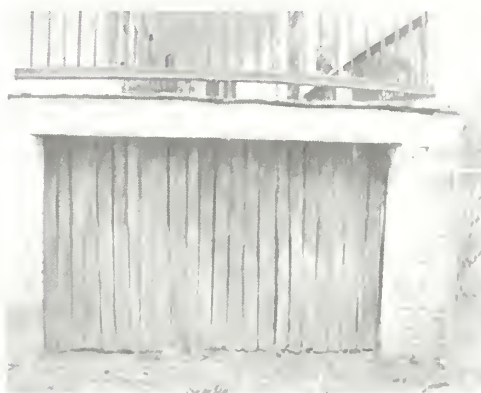
**Figure 41** View of the third type of foundation enclosure. (NPS-SERO-CRS, 2001)

remain from the enclosure of that area. Horizontal boards (now covered with corrugated metal) above a grade-level course of brick are present beneath the west side of Room 214B. Wood-framed walls with horizontal planking were once present between the piers of the kitchen wing, but only fragments of the framing remain in place beneath the east end of the south side of the wing. These walls were reportedly removed in the 1940s.

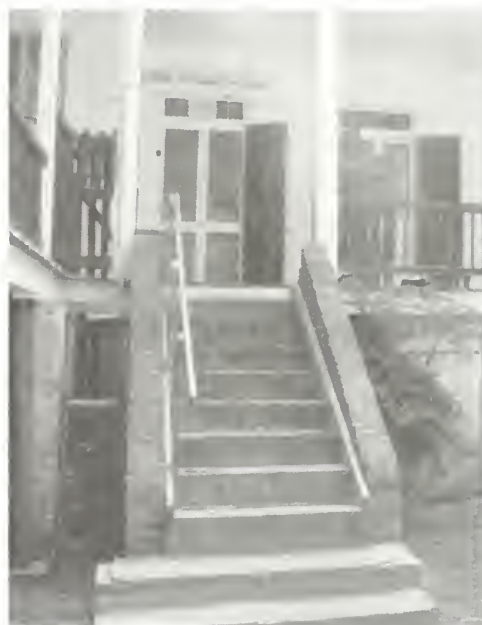
**Figure 44** Brick stairs to rear gallery, shown here, and similar stairs to the south gallery replaced wooden stairs after World War II. Brick stairs to front gallery date to the nineteenth century. (NPS-SERO-CRS, 2001)

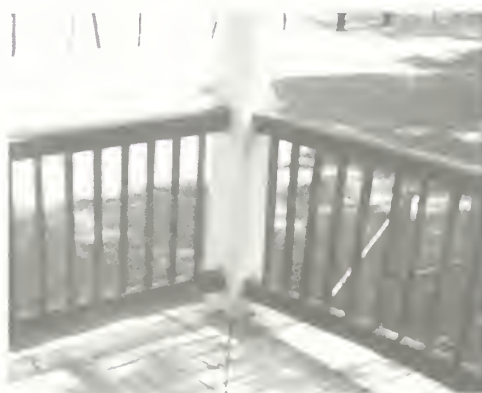
**Figure 45** Typical gallery post, balustrades, and flooring. (NPS-SERO-CRS, 2001)

The main gallery balustrades are approximately 28" high with the bottom rail set about 4" from the floor. The top rail is 3½" by 3" and the bottom rail is 2" by 3"; the edges of both rails are reeded. Balusters are plain, 1" square, and set on 4½" centers. On the south gallery of the old kitchen addition, top rails are 2½" by 3½", bottom rails are 2" by 2½", and 1"- square balusters are set on 4" centers. Wooden gates are located at the tops of the three sets of existing stairs and of the now- missing stairs to the north gallery. Historic photographs show that the gate at the top of the front stairs was not in place around 1910 and the other gates may not have been either. Although the design of these gates does not match the balustrades and appear to have been salvaged from another location, their materials and manner of construction indicate that all four gates date to the nineteenth century. The column on the south side of the front

- Repair floor framing as necessary.
- Replace floor boards as necessary, replacing entire boards as has been done on previous occasions.
- Maintain protective coatings on balustrades and posts.

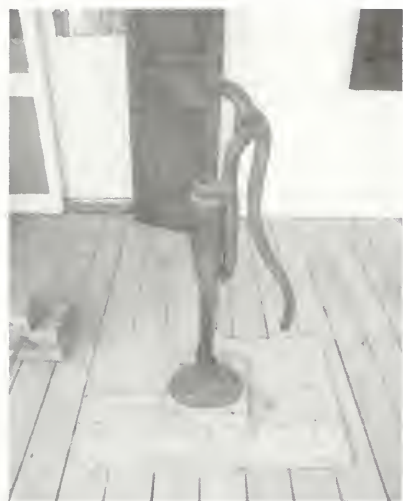
**Figure 48** Myers pump on rear gallery, still connected to cistern located below. (NPS-SERO-CRS, 2001)

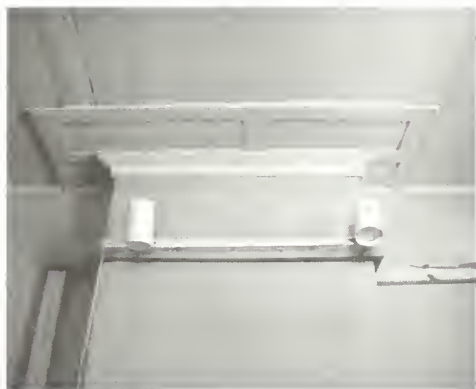
**Figure 49** Board ceiling, typical of those found in most rooms on the main floor of the house. Paneling detail around chimney breast is typical of that found in 202, 205, 206, and 210, although molding details are different in each room. (NPS-SERO-CRS, 2001)

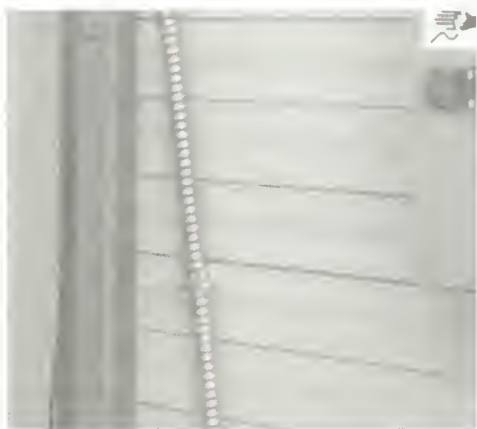
**Figure 50** Typical beaded, tongue-and-groove boards used to panel parts or all of walls and ceilings in 202, 204, 207, 209, 215, and 216. (NPS-SERO-CRS, 2001)

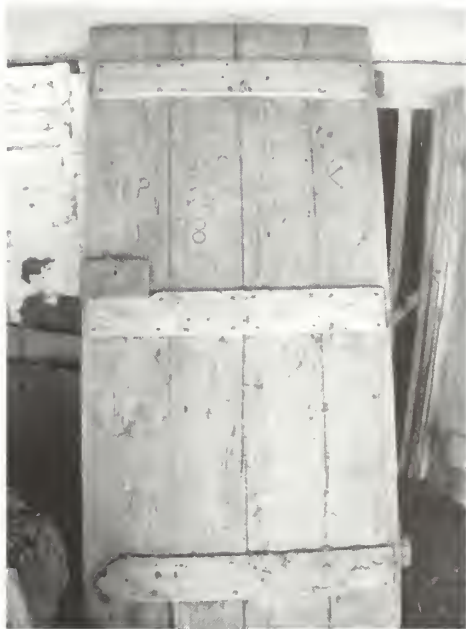
**Figure 51** View of board door at basement level, typical of the oldest doors in the house. (NPS-SERO-CRS, 2001)

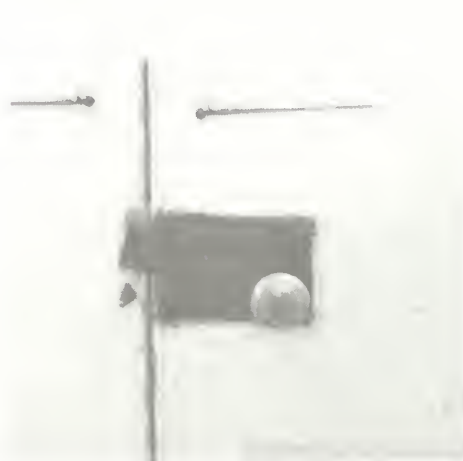
**Figure 53** Early spring lock on French doors in dining room. (NPS-SERO-CRS, 2001)

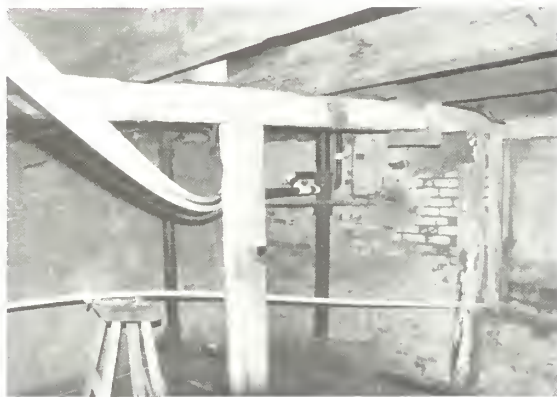
**Figure 54** View southeast in Room 101, showing plumbing lines from bathroom 203. (NPS-SERO-CRS, 2001)

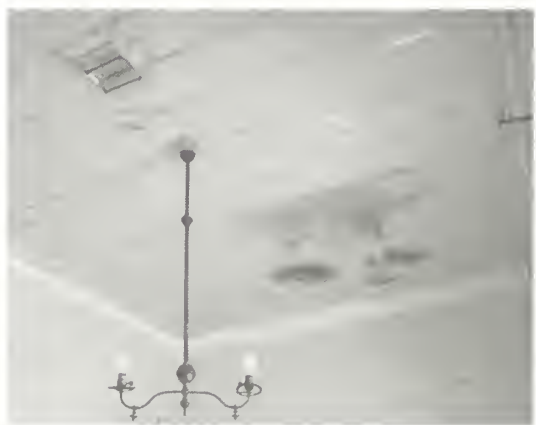
**Figure 95** View of water-damaged ceiling in stranger's room. (NPS-SERO-CRS, 2001)

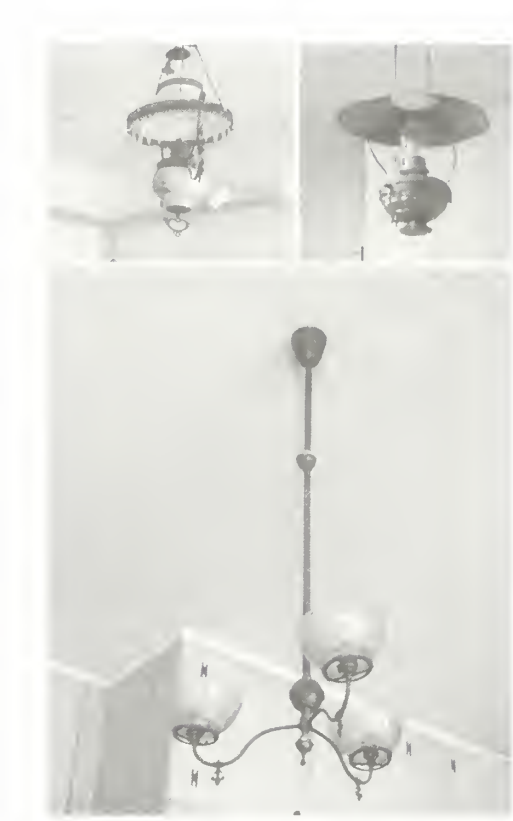
**Figure 112** Top, view of nineteenth- century kerosene light fixtures and, below early twentieth- century gas light fixtures, all of which were converted to electricity in the late 1930s.

- Install new branch circuit wiring to re-feed historic outlets and to feed any new outlets that are deemed necessary.
- Restore and rewire historic lighting fixtures to working order, replacing missing elements as necessary.
- Recreate the historic meter, fuse boxes and associated wiring on south gallery.
- Install complete fire detection and security system.

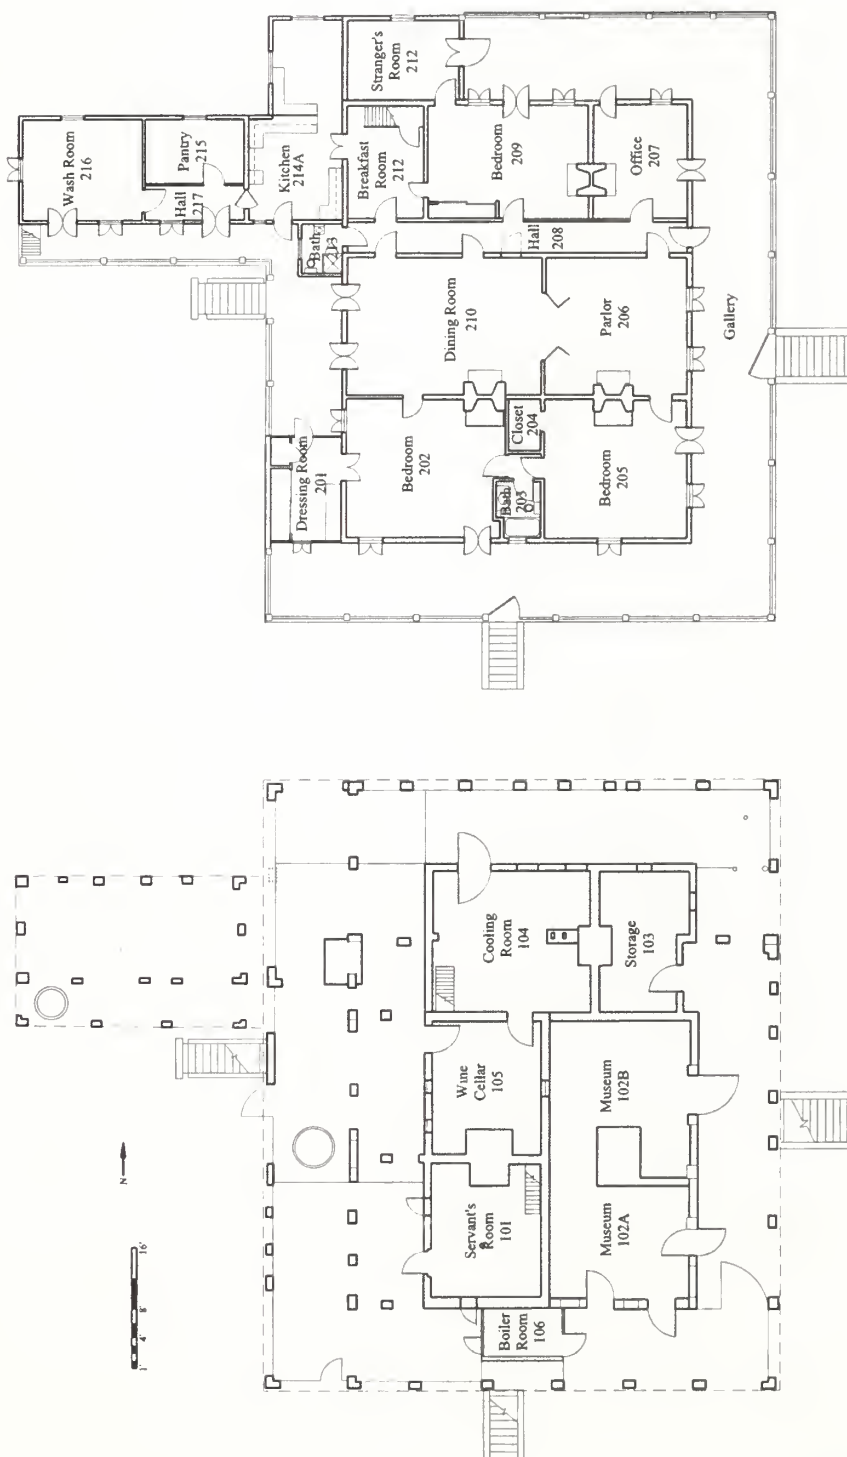
**Figure 113** Plans of existing basement and main story of house.  
(NPS-SERO-CRS, 2001)
